## Bridge Work.

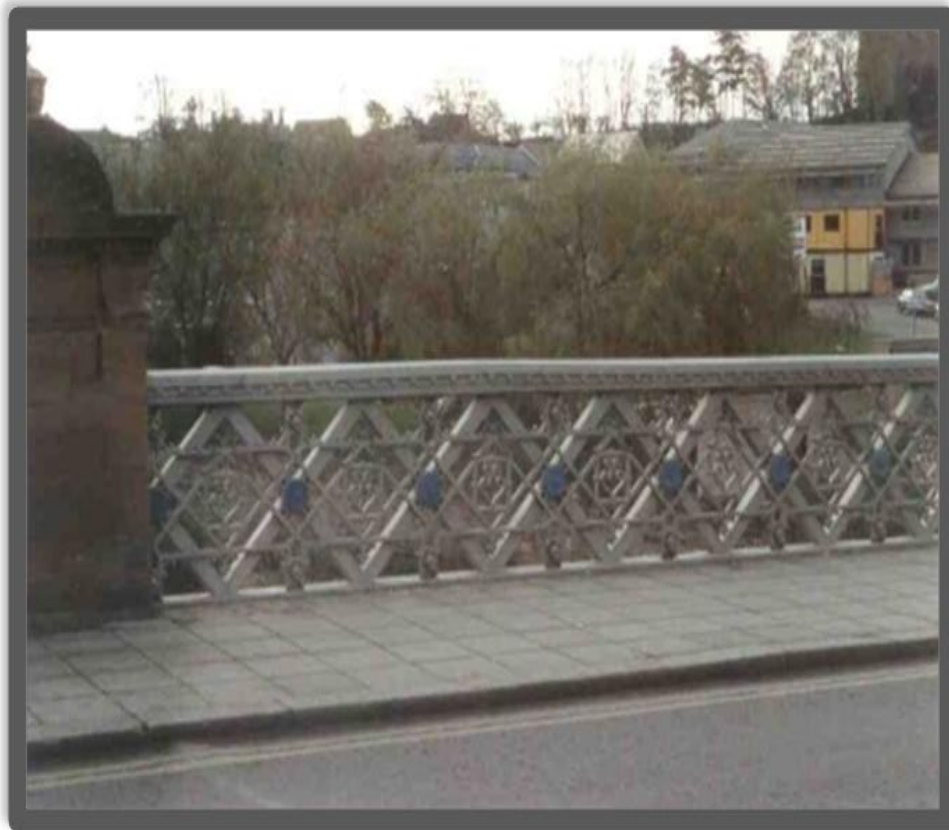
This Bridge in Scotland looks solid, but the top section is in fact lightweight GRP.

Once the local vandals found out it was hollow, they started vandalising it. The voids were filled with high density foam which made the structure strong enough to resist their efforts to break it
